Aznalcóllar dam failure. Part 1: Field observations and material properties

E. E. ALONSO* and A. GENS*

The paper describes the failure of Aznalcóllar dam, in southern Spain, in April 1998. The rockfill dam slid forward and released a flow of acid-saturated tailings. The geology and geomorphology of the site are described. The results of a detailed laboratory testing programme on the tailings material and on the overconsolidated high-plasticity foundation clay are given. Special attention is paid to the identification of cementation of the tailings and to the strength and consolidation properties of the foundation clay. Failure features are interpreted on the basis of the field evidence, taking into account the measured geotechnical properties of the materials involved.

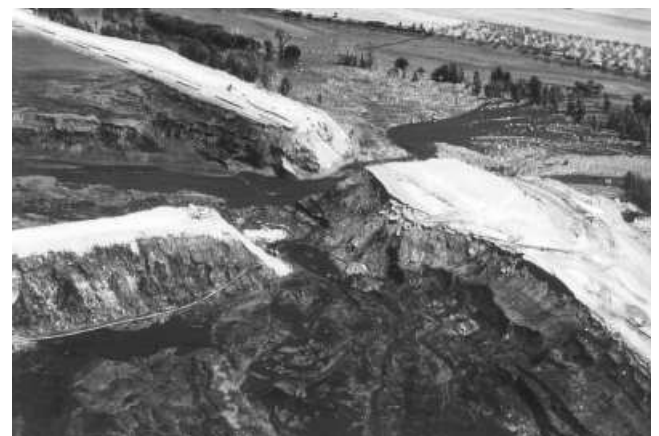
Fig. 4. Two aerial views of the breached dam a few hours after the failure: (a) view from the east; (b) detail of the breach

The orientation of the initial outflow is indicated by the depositional fans observed outside the breached embankment (Fig. 4(b)). The flow of tailings was directed initially in a NE direction, against the natural slope of the Agrio valley. Later, the progressive erosion of the breach allowed the outflow to change direction towards the east.

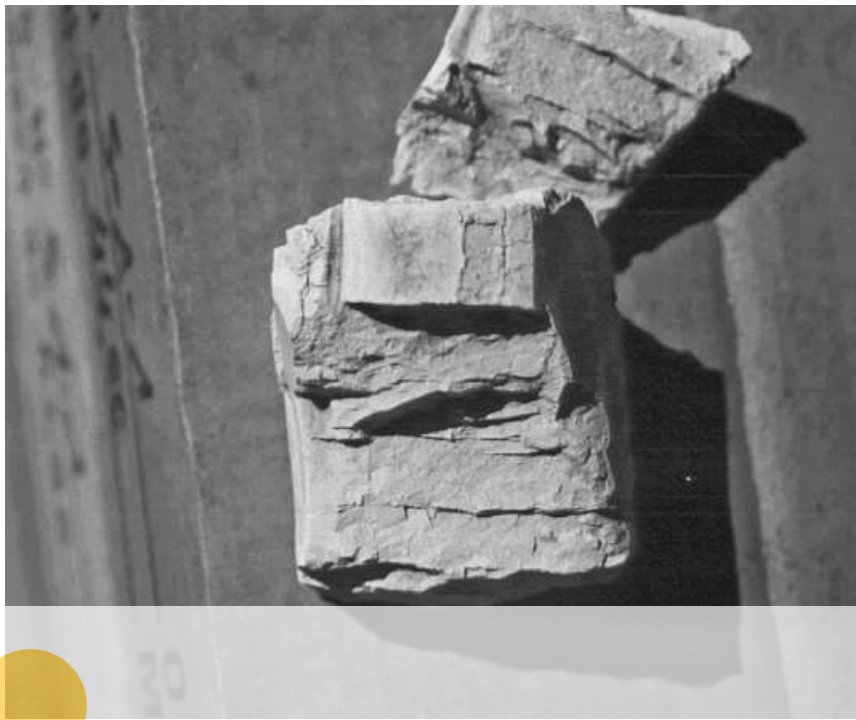
are exposed to the atmosphere and partially dried, some laminations and the alignments of pyrite micronodules reveal the bedding planes (Fig. 7). In exposed outcrops outside the slide area (Fig. 8) the weathered clay exhibits the bedding planes more clearly. A dip of $2-4^\circ$ towards the SSE was measured in outcrops and trenches. Observations in bedding planes, both in outcrops and in cores, revealed some shear striations and some shear zones similar to those described in Chandler *et al.* (1998). Two examples of shear striations are shown in Figs 9 and 10. However, these phenomena were not general, and in other cases the bedding planes appeared

Fig. 7. Stratification of clay as observed in a partially dried core (borehole S1-3; depth 19 m)

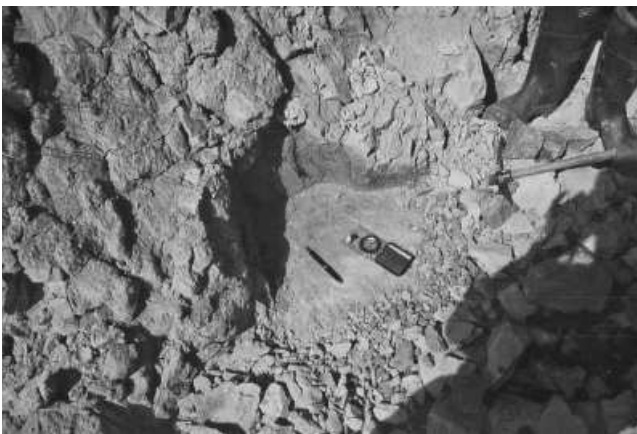
Fig. 9. Slickensides exposed on a bedding plane: river bank of Agrio river

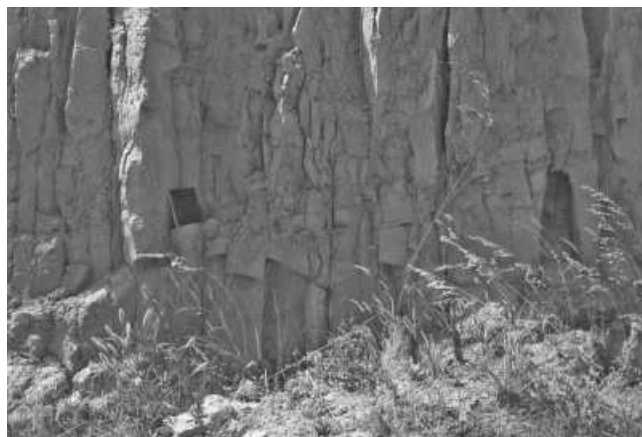
Fig. 11. Vertical jointing: outcrops in Agrio river

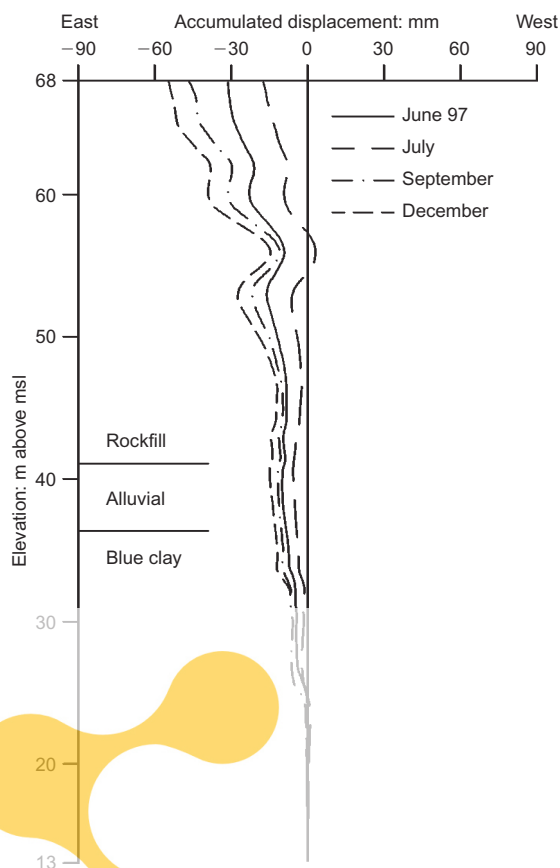
Inclinometer I-3 was located approximately at the centre of the section of the embankment that slid towards the river at the time of failure. A few readings were made during December 1996–December 1997. They are shown in Fig. 14. The locations of the rockfill/alluvial and alluvial/clay interfaces are shown in the figure. Unfortunately, the upper part of the inclinometer was damaged in January 1998, and no data for the months immediately preceding the failure are available. The displacements shown in Fig. 14 were not

interpreted at the time of readings, as a sign of a possible deep sliding. It was later established, after the failure, that a sliding surface developed at elevation 26 m. Six millimetres of displacements accumulated at this elevation during the year 1997. Most of the observed displacements were recorded within the rockfill embankment, which was under construction.

Fig. 14. Readings in inclinometer I-3 in direction perpendicular to dam axis (towards the east)

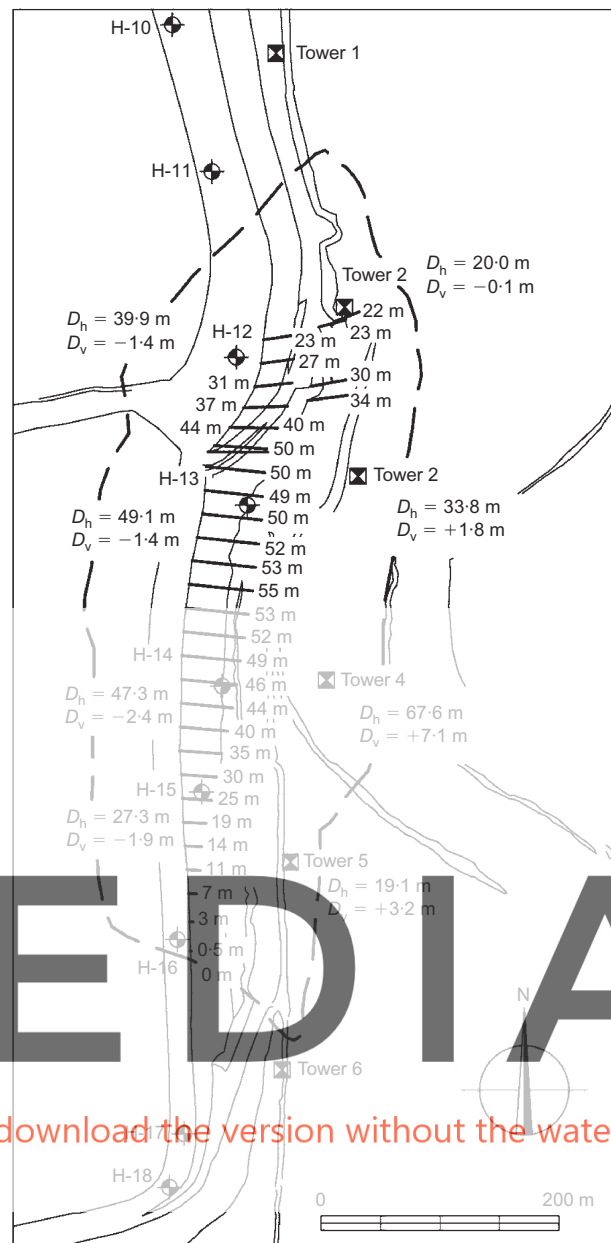
Fig. 16. Limits of the slide area and vectors indicating the displacement. Displacements were measured in topographic marks and electrical towers. D_h , horizontal displacement; D_v , vertical displacement (negative numbers indicate a drop in elevation)

The central part of the embankment moved 40–55 m towards the east (directions varied between 93° and 100° with respect to north). The magnitude of the displacement decreased to 20–22 m at the northern limit of the slide, at the position of the open breach. Towards the south, a more gradual decrease of displacements was observed. In total, a 600 m long portion of the south-eastern embankment of the lagoon was affected by the slide. North of the breach, no displacements of the embankment were detected.

The shape of the northern limit of the slide (Fig. 16) suggests that the failure surface crossing the embankment was controlled by the dominant orientation (NE–SW) of the vertical joints of the foundation clay. An interpretation of the original rupture breach is given in Fig. 23. The orientation of the embankment, its size, the direction and intensity of the sliding motion and the orientation of the rupture plane led to an initial breach width of 14 m. Note also that the two lips of the breach separated immediately, and therefore

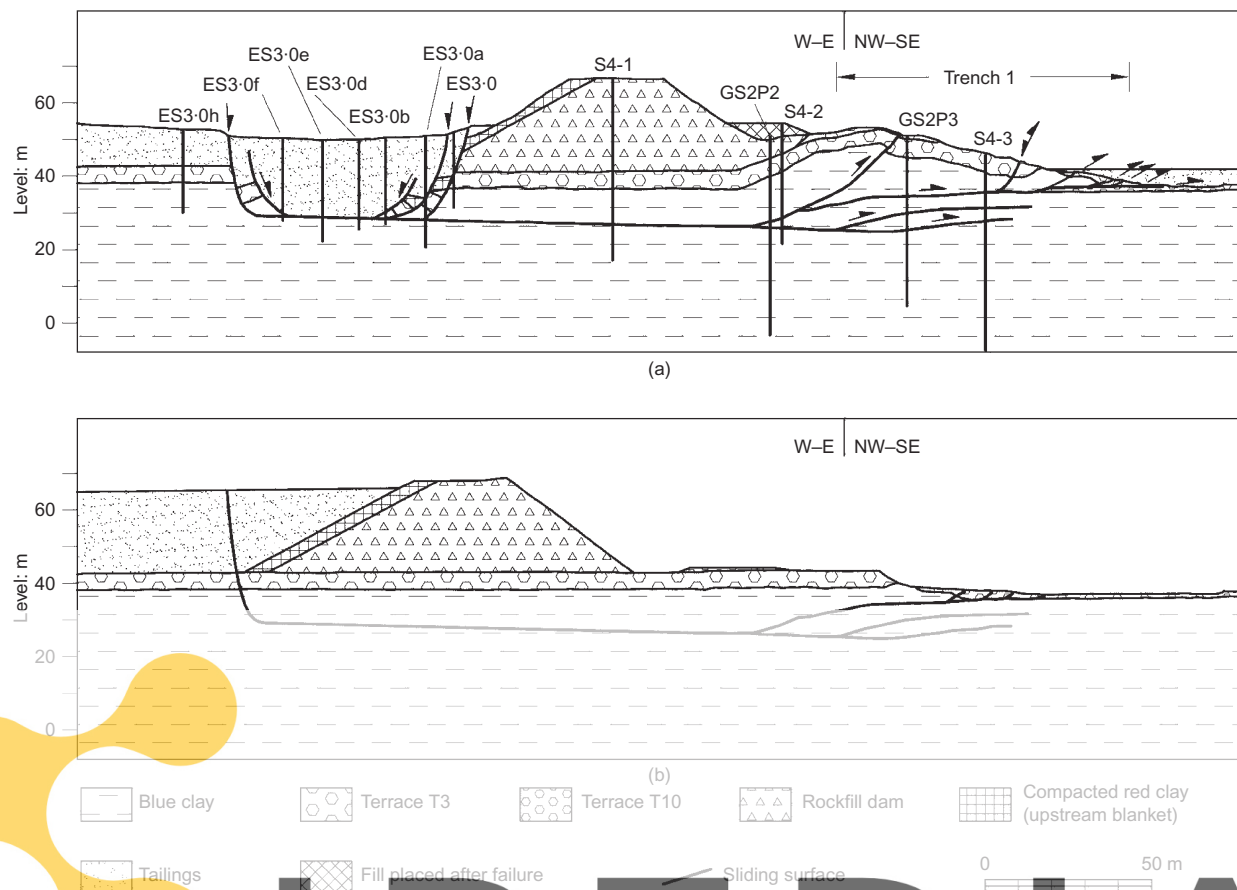
Fig. 17. Cross-section of slide at position of Profile 4: (a) geometry after the slide, as interpreted from borehole results and surface topography; (b) reconstruction of position of sliding surfaces before failure

found in direct contact with the clay in some of them (e.g. Boring ES3-0e in Fig. 17). In several boreholes it was also possible to identify the position of the sliding surface where a highly polished surface could be found. This is the case for the plane shown in Fig. 18.

Also indicated in Fig. 17(a) are the folded structures found at the foot of the downstream slope of the embankment. The interpretation given is based on zones of intense shearing found in boreholes and trenches. Upward displacements of the ground, close to 8 m, were measured at the position of the folded strata. Fig. 17(b) provides a reconstruction of the original position of the sliding surface before failure displacements. An interesting finding of this reconstruction is that the head scar of the slide was a near-vertical surface located at the original upstream toe of the embankment. This vertical scar was fairly well preserved even after the intense erosion of the tailings deposits that followed the uncontrolled flow out of the lagoon. This is shown in Fig. 19.

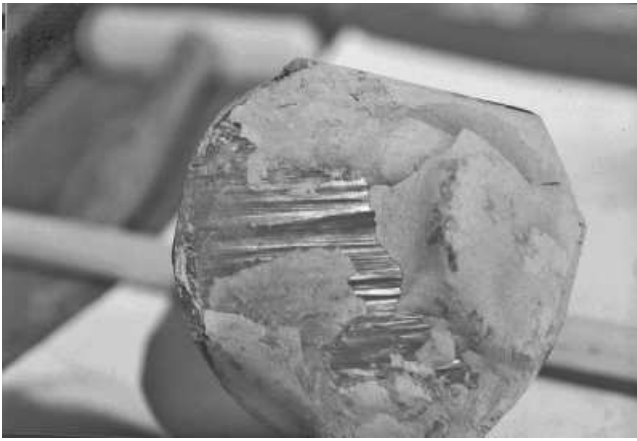
Fig. 18. Highly polished and striated shear plane that follows a bedding plane (S_0). Borehole 2-1 at 33.8 m depth. It was interpreted as belonging to the sliding surface

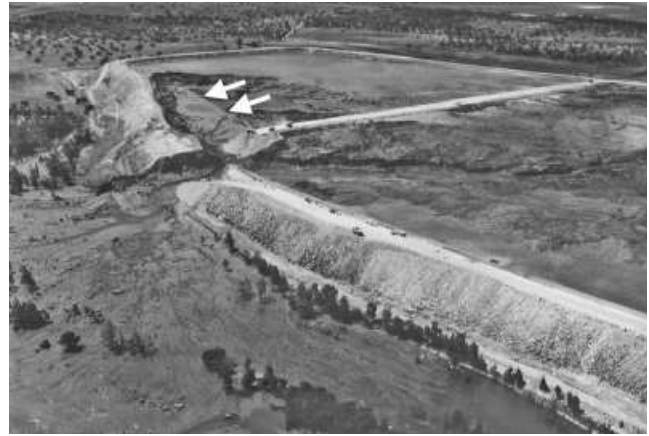
Fig. 19. The straight line, indicated by arrows, shows the position of the upstream scar of the slide
